DOI: 10.31643/2025/6445.08

Metallurgy

The influence of the hydrogenation process on the microstructure and properties of metallic materials

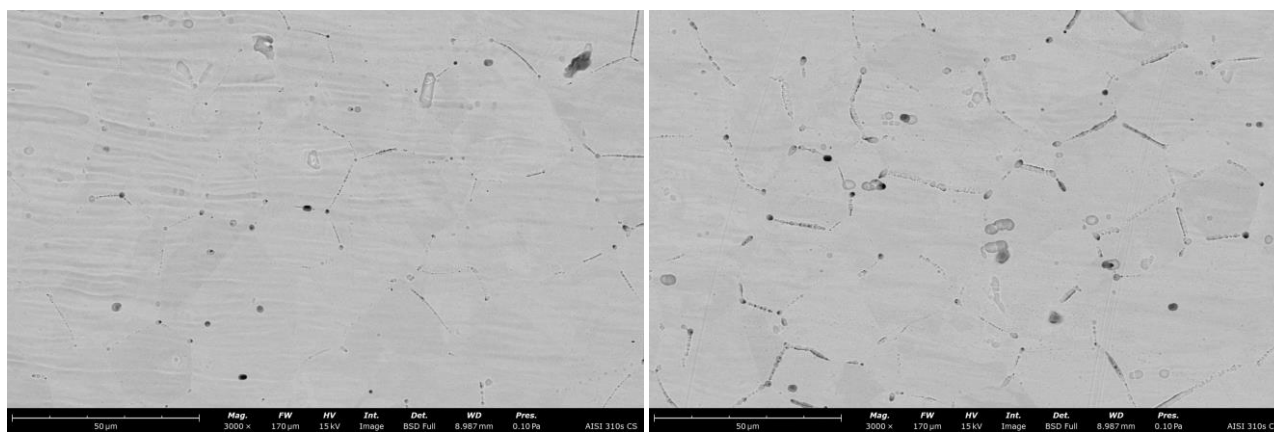
Fig. 1 - Microstructure of alloyed austenite with evolved carbons at grain boundaries in AISI 310s steel in the supply state. SEM

The material in the form of commercially available AISI 310s steel was selected for the tests (jfs-steel.com). The tested steel showed a microstructure, equiaxed alloy austenite grains with precipitations of carbides forming a shell at the grain boundaries (Fig. 1.). In the delivery state, according to the supplier, the material was characterized by the chemical composition given in tab. 1. and showed the properties presented in tab. 2. Membranes for the tests were prepared in the form of plates with a thickness of 0.7 mm, dimensions shown in Fig. 2. The area of interaction with the electrolyte during electrochemical processes was about 550 mm² and was the same for each sample. The surface of the materials before the electrochemical process was cleaned in an ultrasonic scrubber in an acetone solution for 10 minutes.

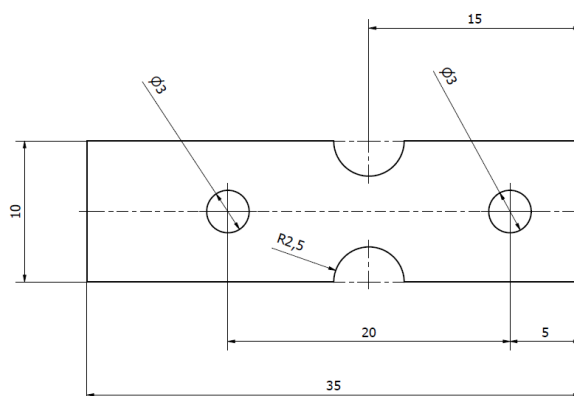
**Fig. 2** - Austenitic steel membrane dimensions

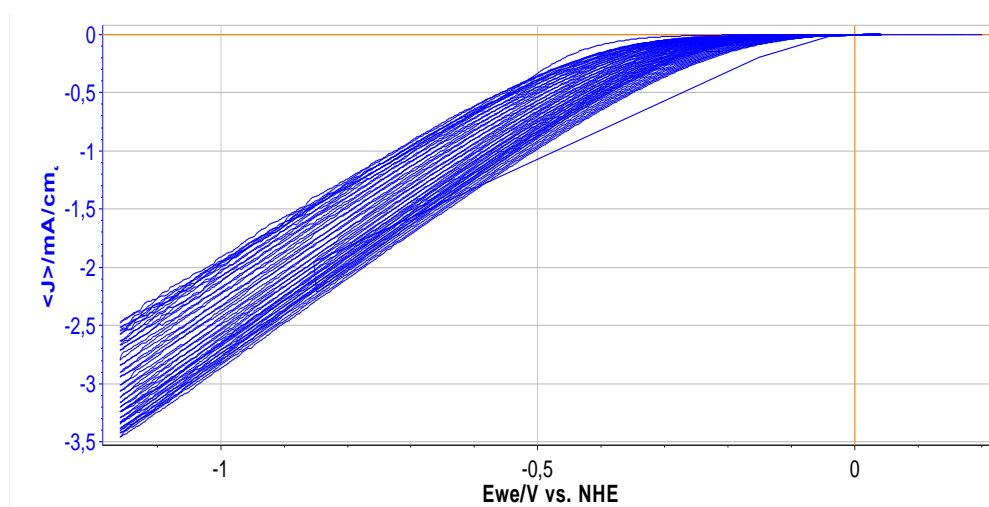
Fig. 3 - Cyclic Voltammetry curve after 25 hydrogen cycles in $0,5\text{MH}_2\text{SO}_4$

Voltammetry measurements CV showed in all cycles similar shape of the curves, during observations the hydrogenation process showed an increasingly intense and violet process of hydrogen evolution in the lower parts of the graph. The most intensive hydrogenation process took place in the range below 0.5 Ewe, numerous hydrogen bubbles were visible, concentrating on the surface of the metallic membrane constituting the working electrode. In subsequent hydrogenation cycles, the

current values decreased in the range of -2.5mA/cm to -3.5mA/cm for 25 cycles (Fig. 3). For hydrogenation in 50 cycles, the current values were lower and oscillated from -3.0mA/cm to -6mA/cm (Fig. 4). Differences in the initial values result from differences in the closed-circuit measurement values in a given electrode system. There is a clear tendency to decrease the current values in successive hydrogenation cycles. This proves the changes taking place in the metallic membranes and the change of their electrochemical potentials about the material in the delivery state.

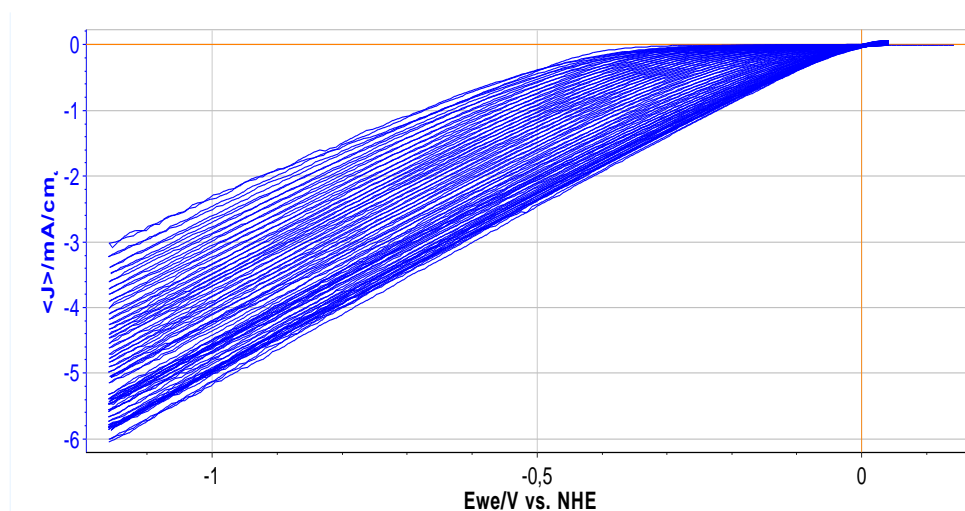
Fig. 4 - Cyclic Voltammetry curve after 50 hydrogen cycles in $0,5\text{MH}_2\text{SO}_4$

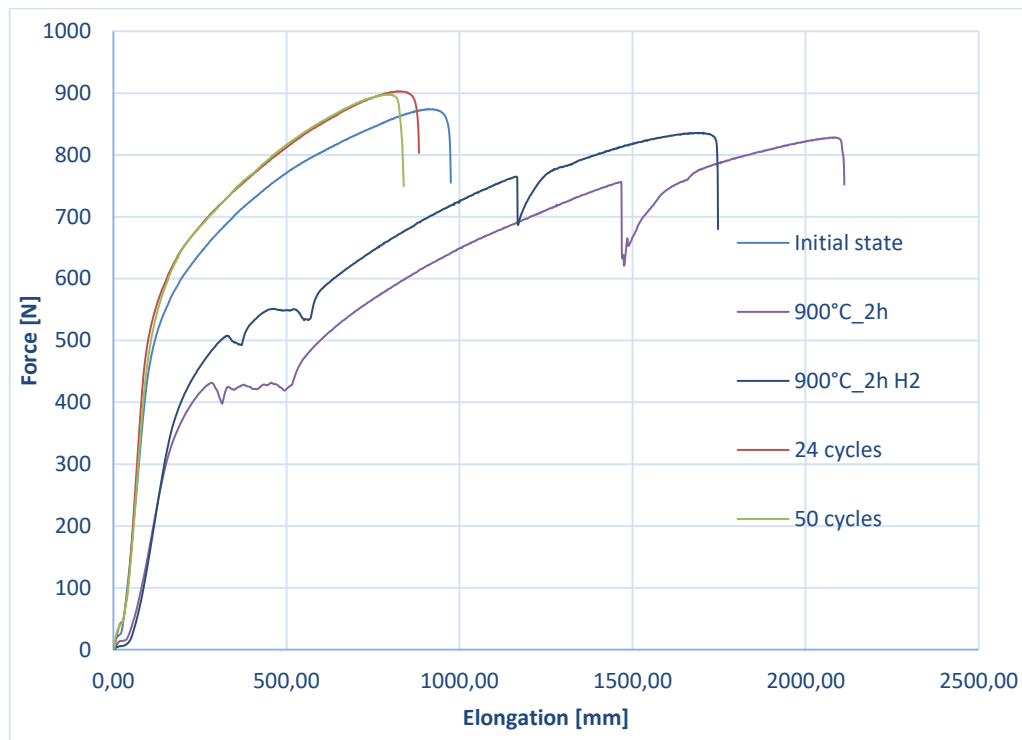
Fig. 5 - Tensile curves for delivery state and after hydrogenation proces

The samples after the hydrogenation process were subjected to axial tensile testing at a constant speed of 0.5 mm/s inside a scanning electron microscope chamber equipped with a tensile holder with a maximum measurement force of 1 kN. All the tensile tests were conducted in a single setup, creating geometric notches in the central part of the samples. As a result of the tensile testing, the maximum force and elongation were determined, which were considered as comparative values due to the identical geometry of the samples (Fig. 5). The hydrogenation process after 25 and 50 cycles resulted in a slight strengthening of the material, increasing the maximum force value by 3%, which represents a minor change. On the other hand, the elongation value underwent a significant reduction, decreasing by 9% after 25 cycles of hydrogenation and 13% after 50 cycles of hydrogenation compared to the reference state. This indicates a negative impact of the hydrogen environment on AISI 310S steel.

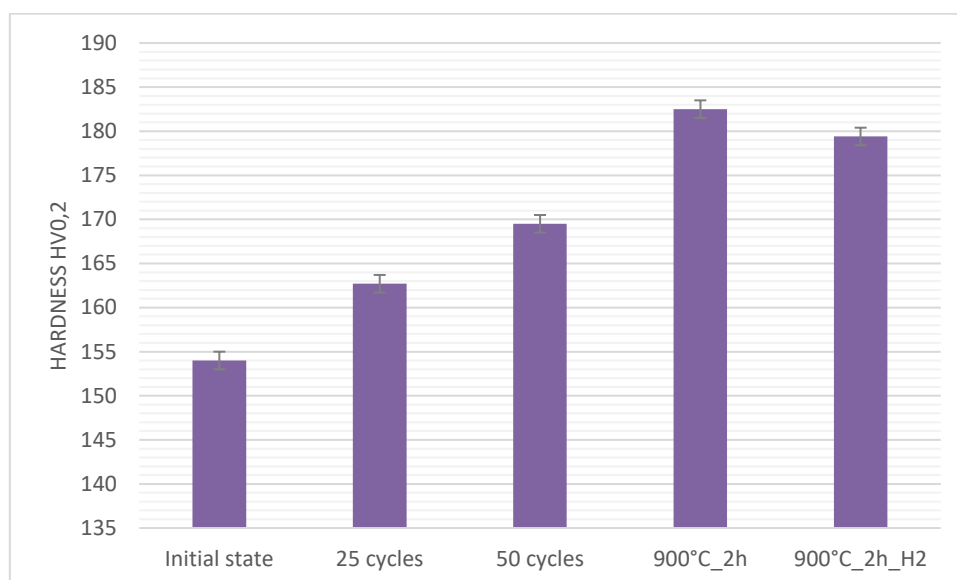
Fig. 6 - Averaged hardness measurement results for metallic membranes

were carried out on the surface of the membranes, on the undeformed elements of the sample after both the hydrogenation process. Analysis of the microhardness results showed that the H₂ environment affects the surface hardening of AISI 310s steel (Fig. 6).

An increase in hardness compared to the initial state material was observed in all tested materials. Hydrogen charging in electrolytic processes resulted in an increase in hardness from 154HV_{0.2} to 162HV_{0.2}. A linear increase in this parameter was observed when the number of cycles was increased to 50, where the hardness increased to 169HV_{0.2}. The hydrogenation process at a temperature of 900°C also increased the hardness to 182HV_{0.2} for the membrane heated in an oxygen atmosphere and to 179HV_{0.2} for the environment enriched with hydrogen particles. The reduced hardness of the material after heat treatment in a hydrogen atmosphere seems puzzling, it may be related to the presence of atomic hydrogen, which only changes to a molecular form when the material is loaded and results in increased brittleness.

In the electrochemical hydrogenation process, an increase in hardness was found commensurate with the increasing number of hydrogenation cycles.
